# Fire Risk Assessment

## JOHN BOWLEY AND SHERWOOD ALMSHOUSES

John Bowley House  
340 Cheriton Road  
Cheriton  
Kent  
CT19 4DR

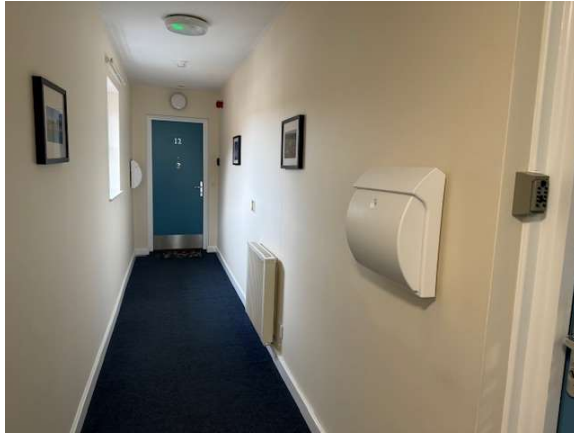
Photograph 1:

Letterboxes replace letter slots in apartment doors.

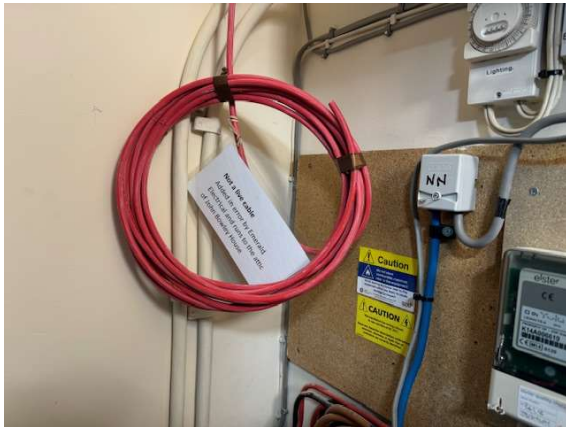
Photograph 2:

Reel of unused cable in the ground floor service cupboard

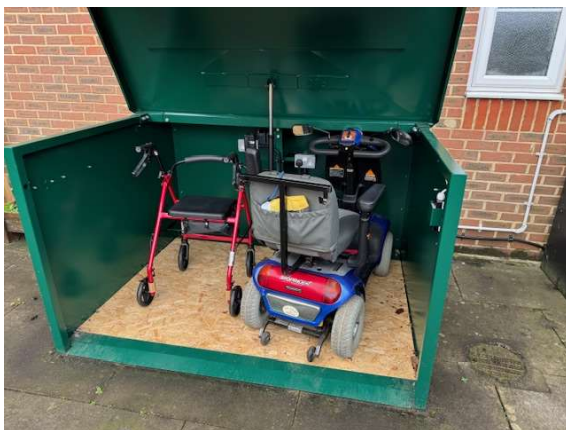
Photograph 3:

Additional scooter store
